# Engineering Geology for protecting Cultural Heritages around the world: some case studies

**Claudio Margottini**

UNESCO Chair on the Prevention and  
Sustainable Management of Geo-  
Hydrological Hazards, University of  
Florence

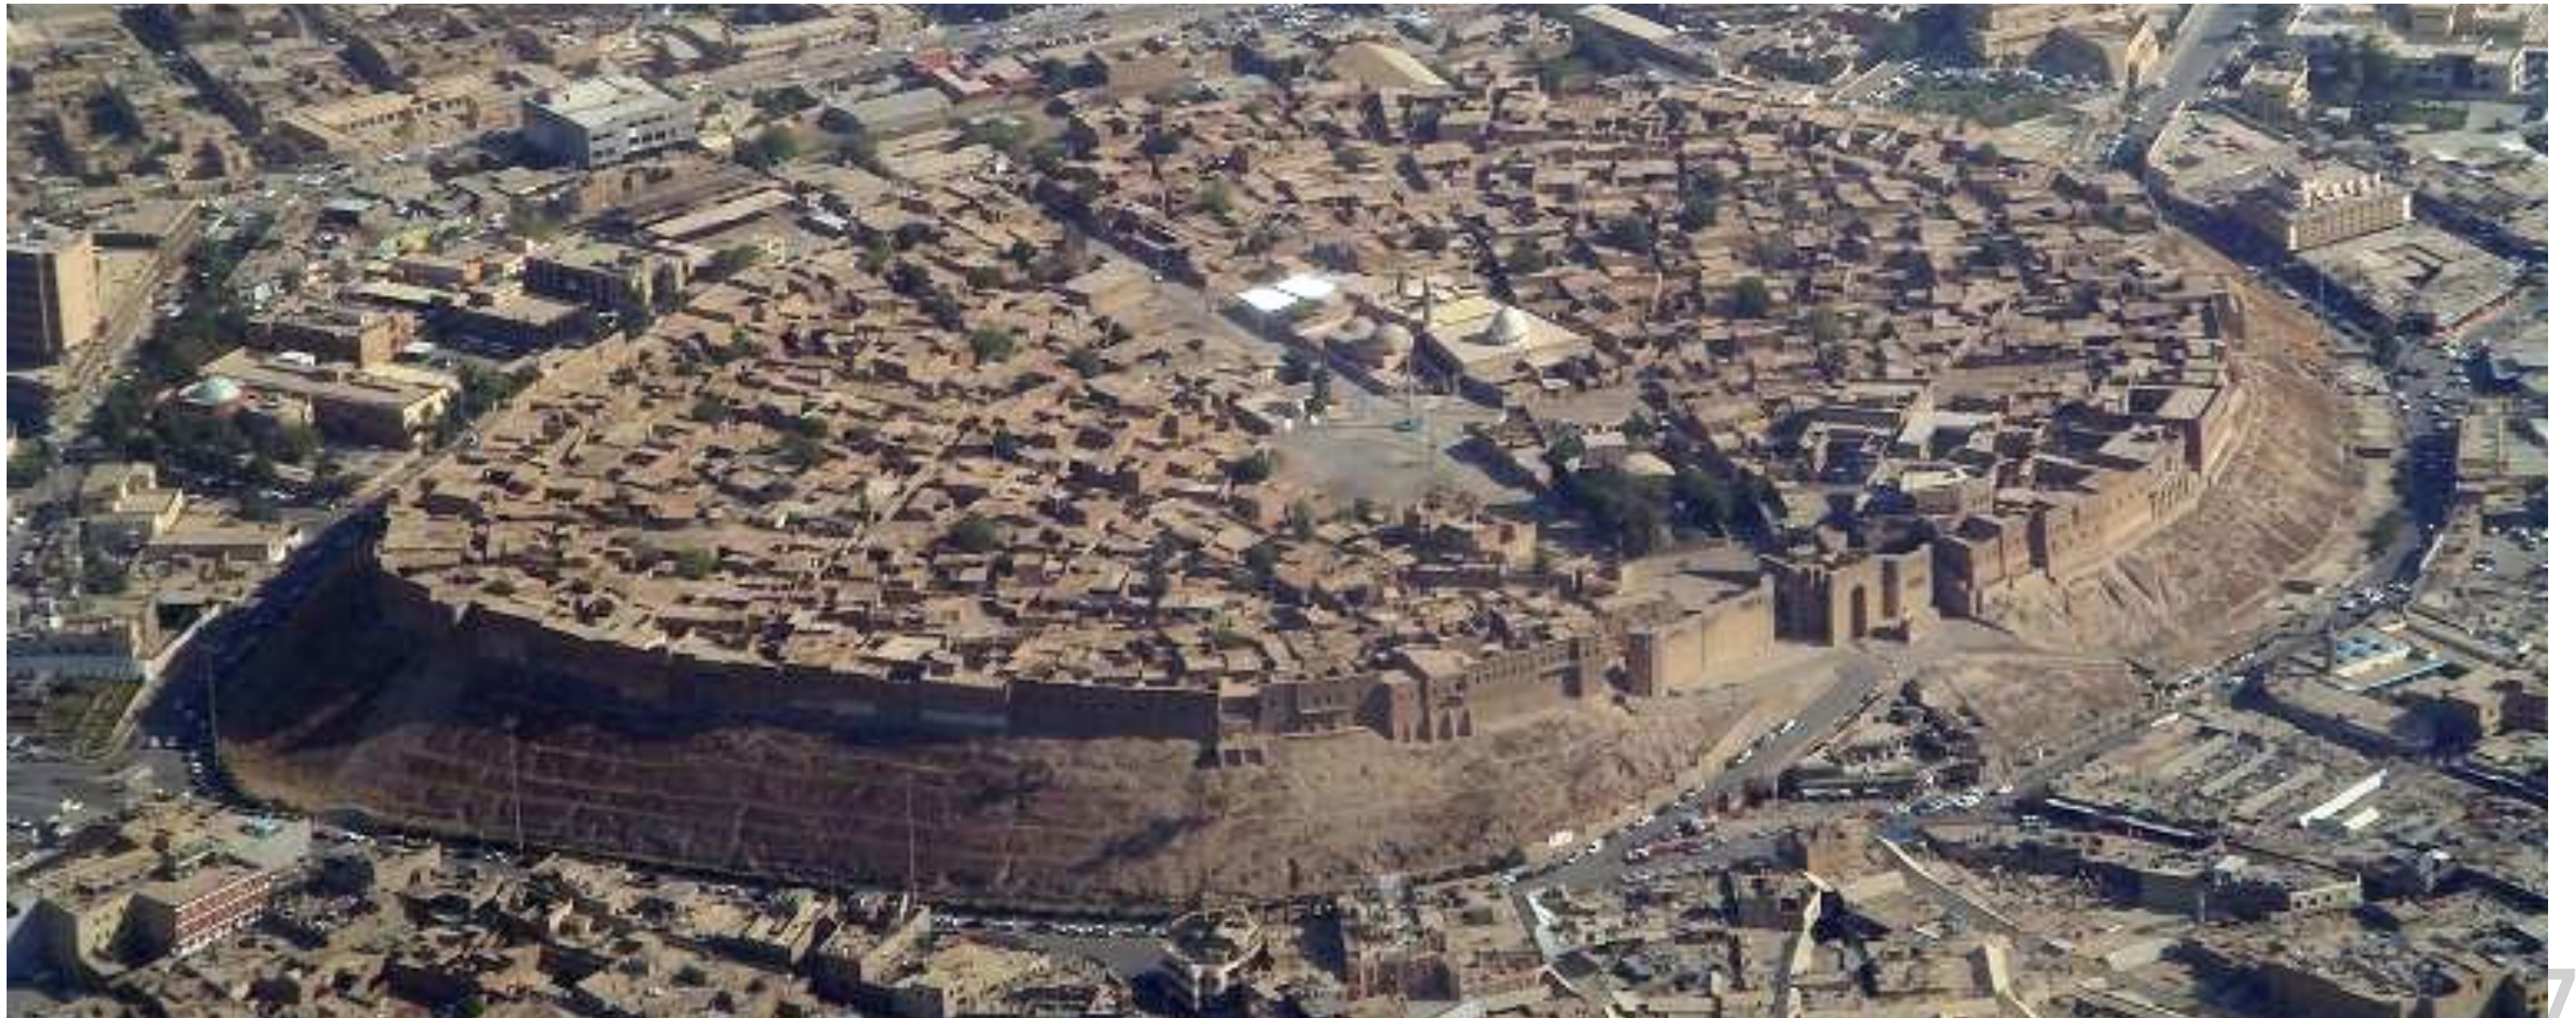
Erbil, Kuridstan, Iraq

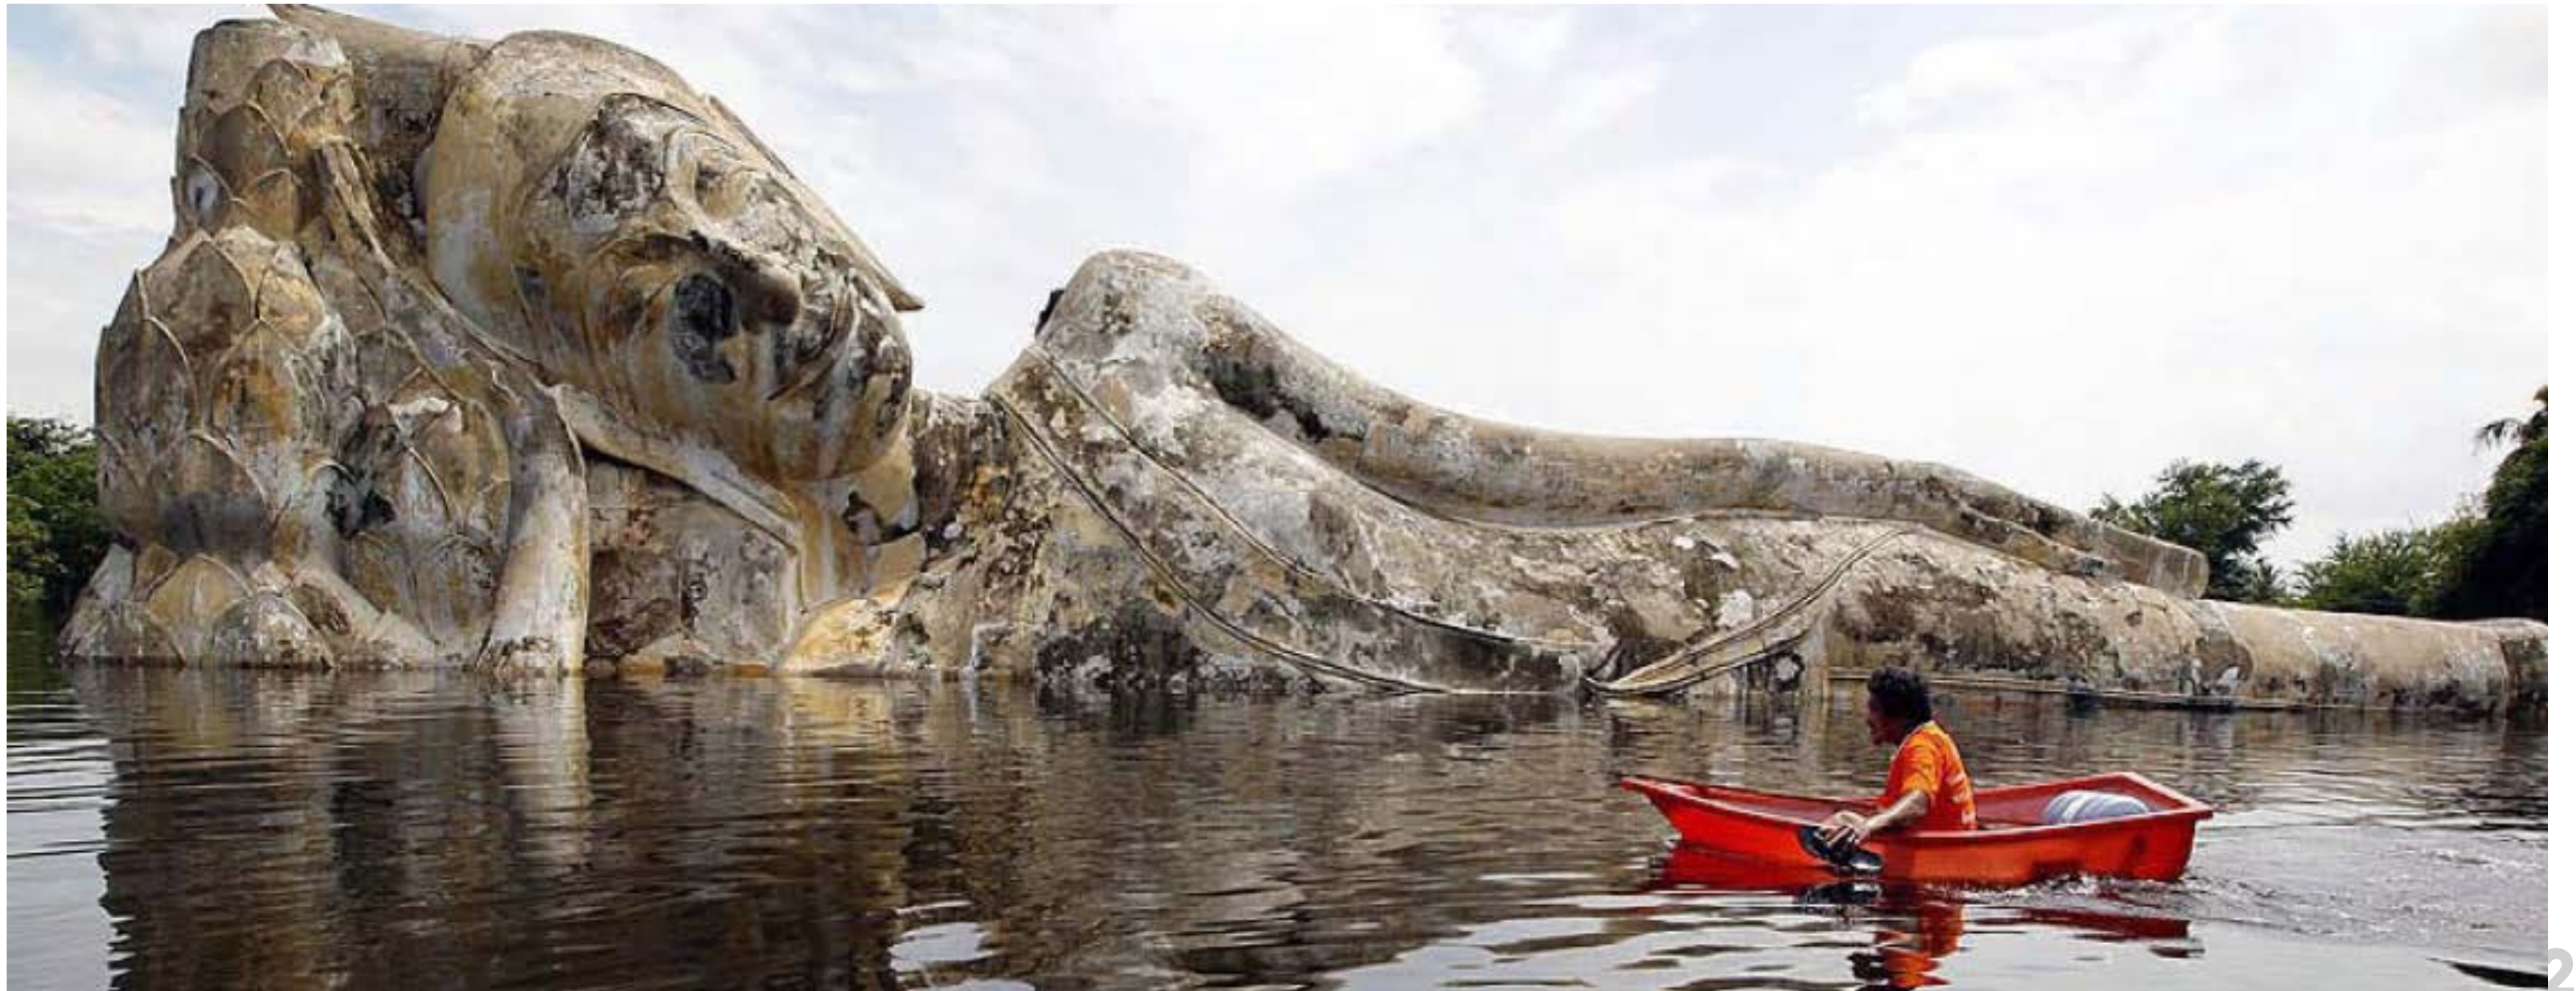
# Flood Event

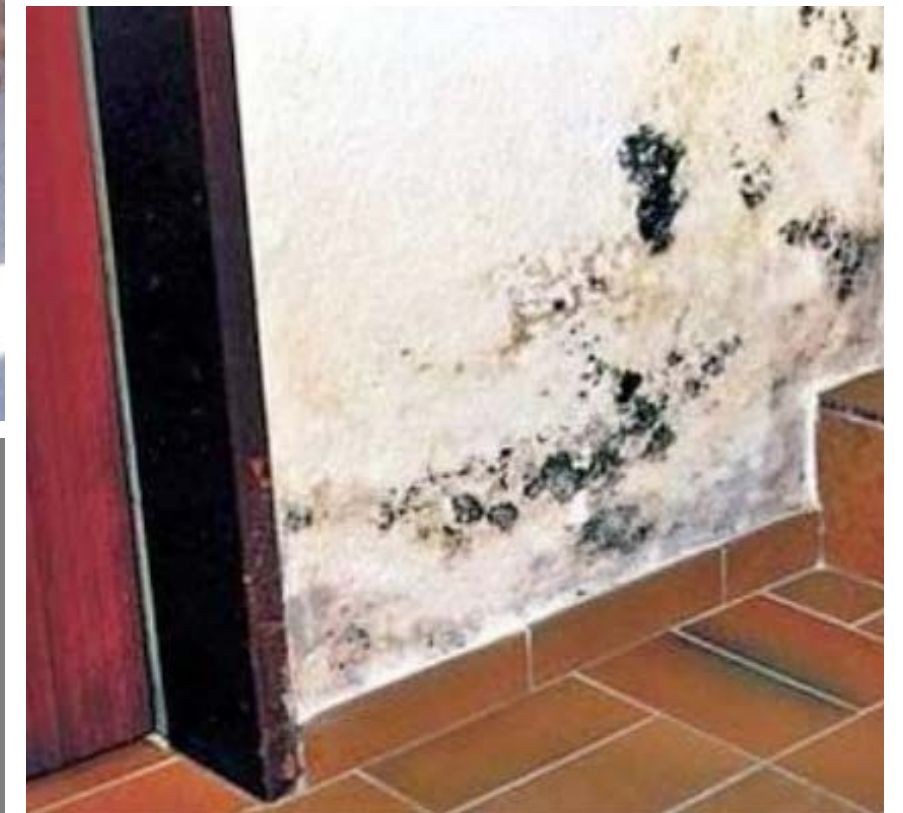
Condensation  
(moisture)  
(occasionally)  
Rome (Italy)

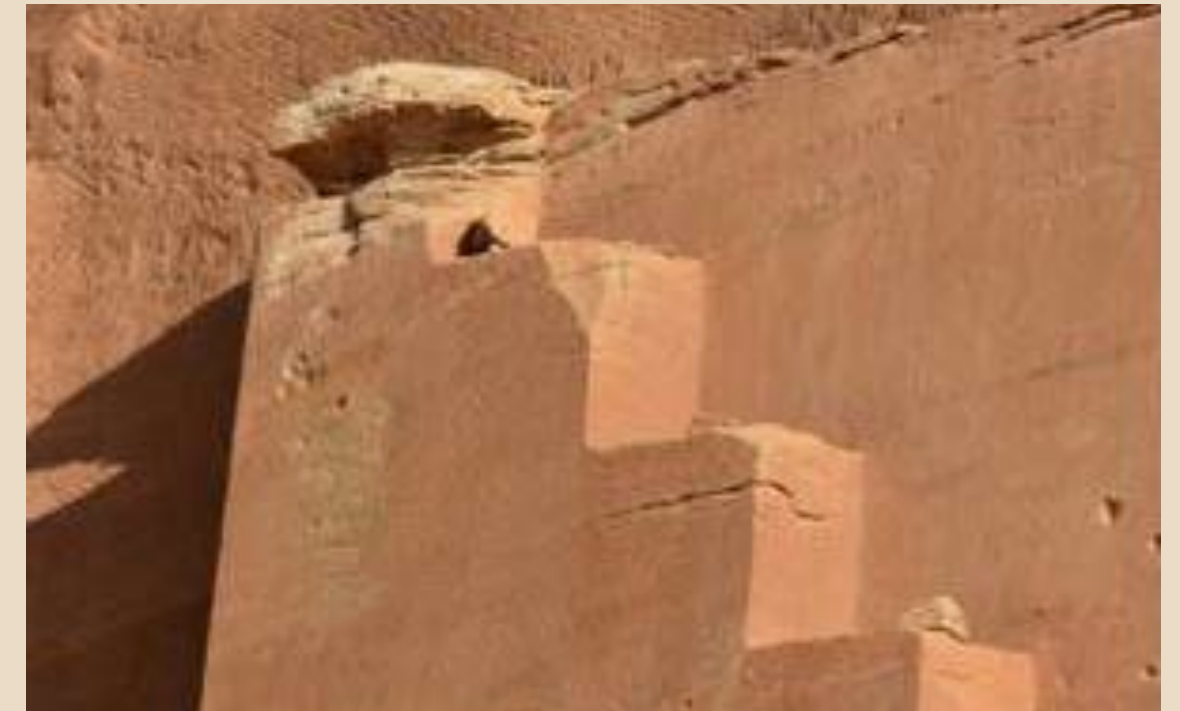
Roof collapse

Roof collapse inside the Jabal Idilib and Al Diwan complex

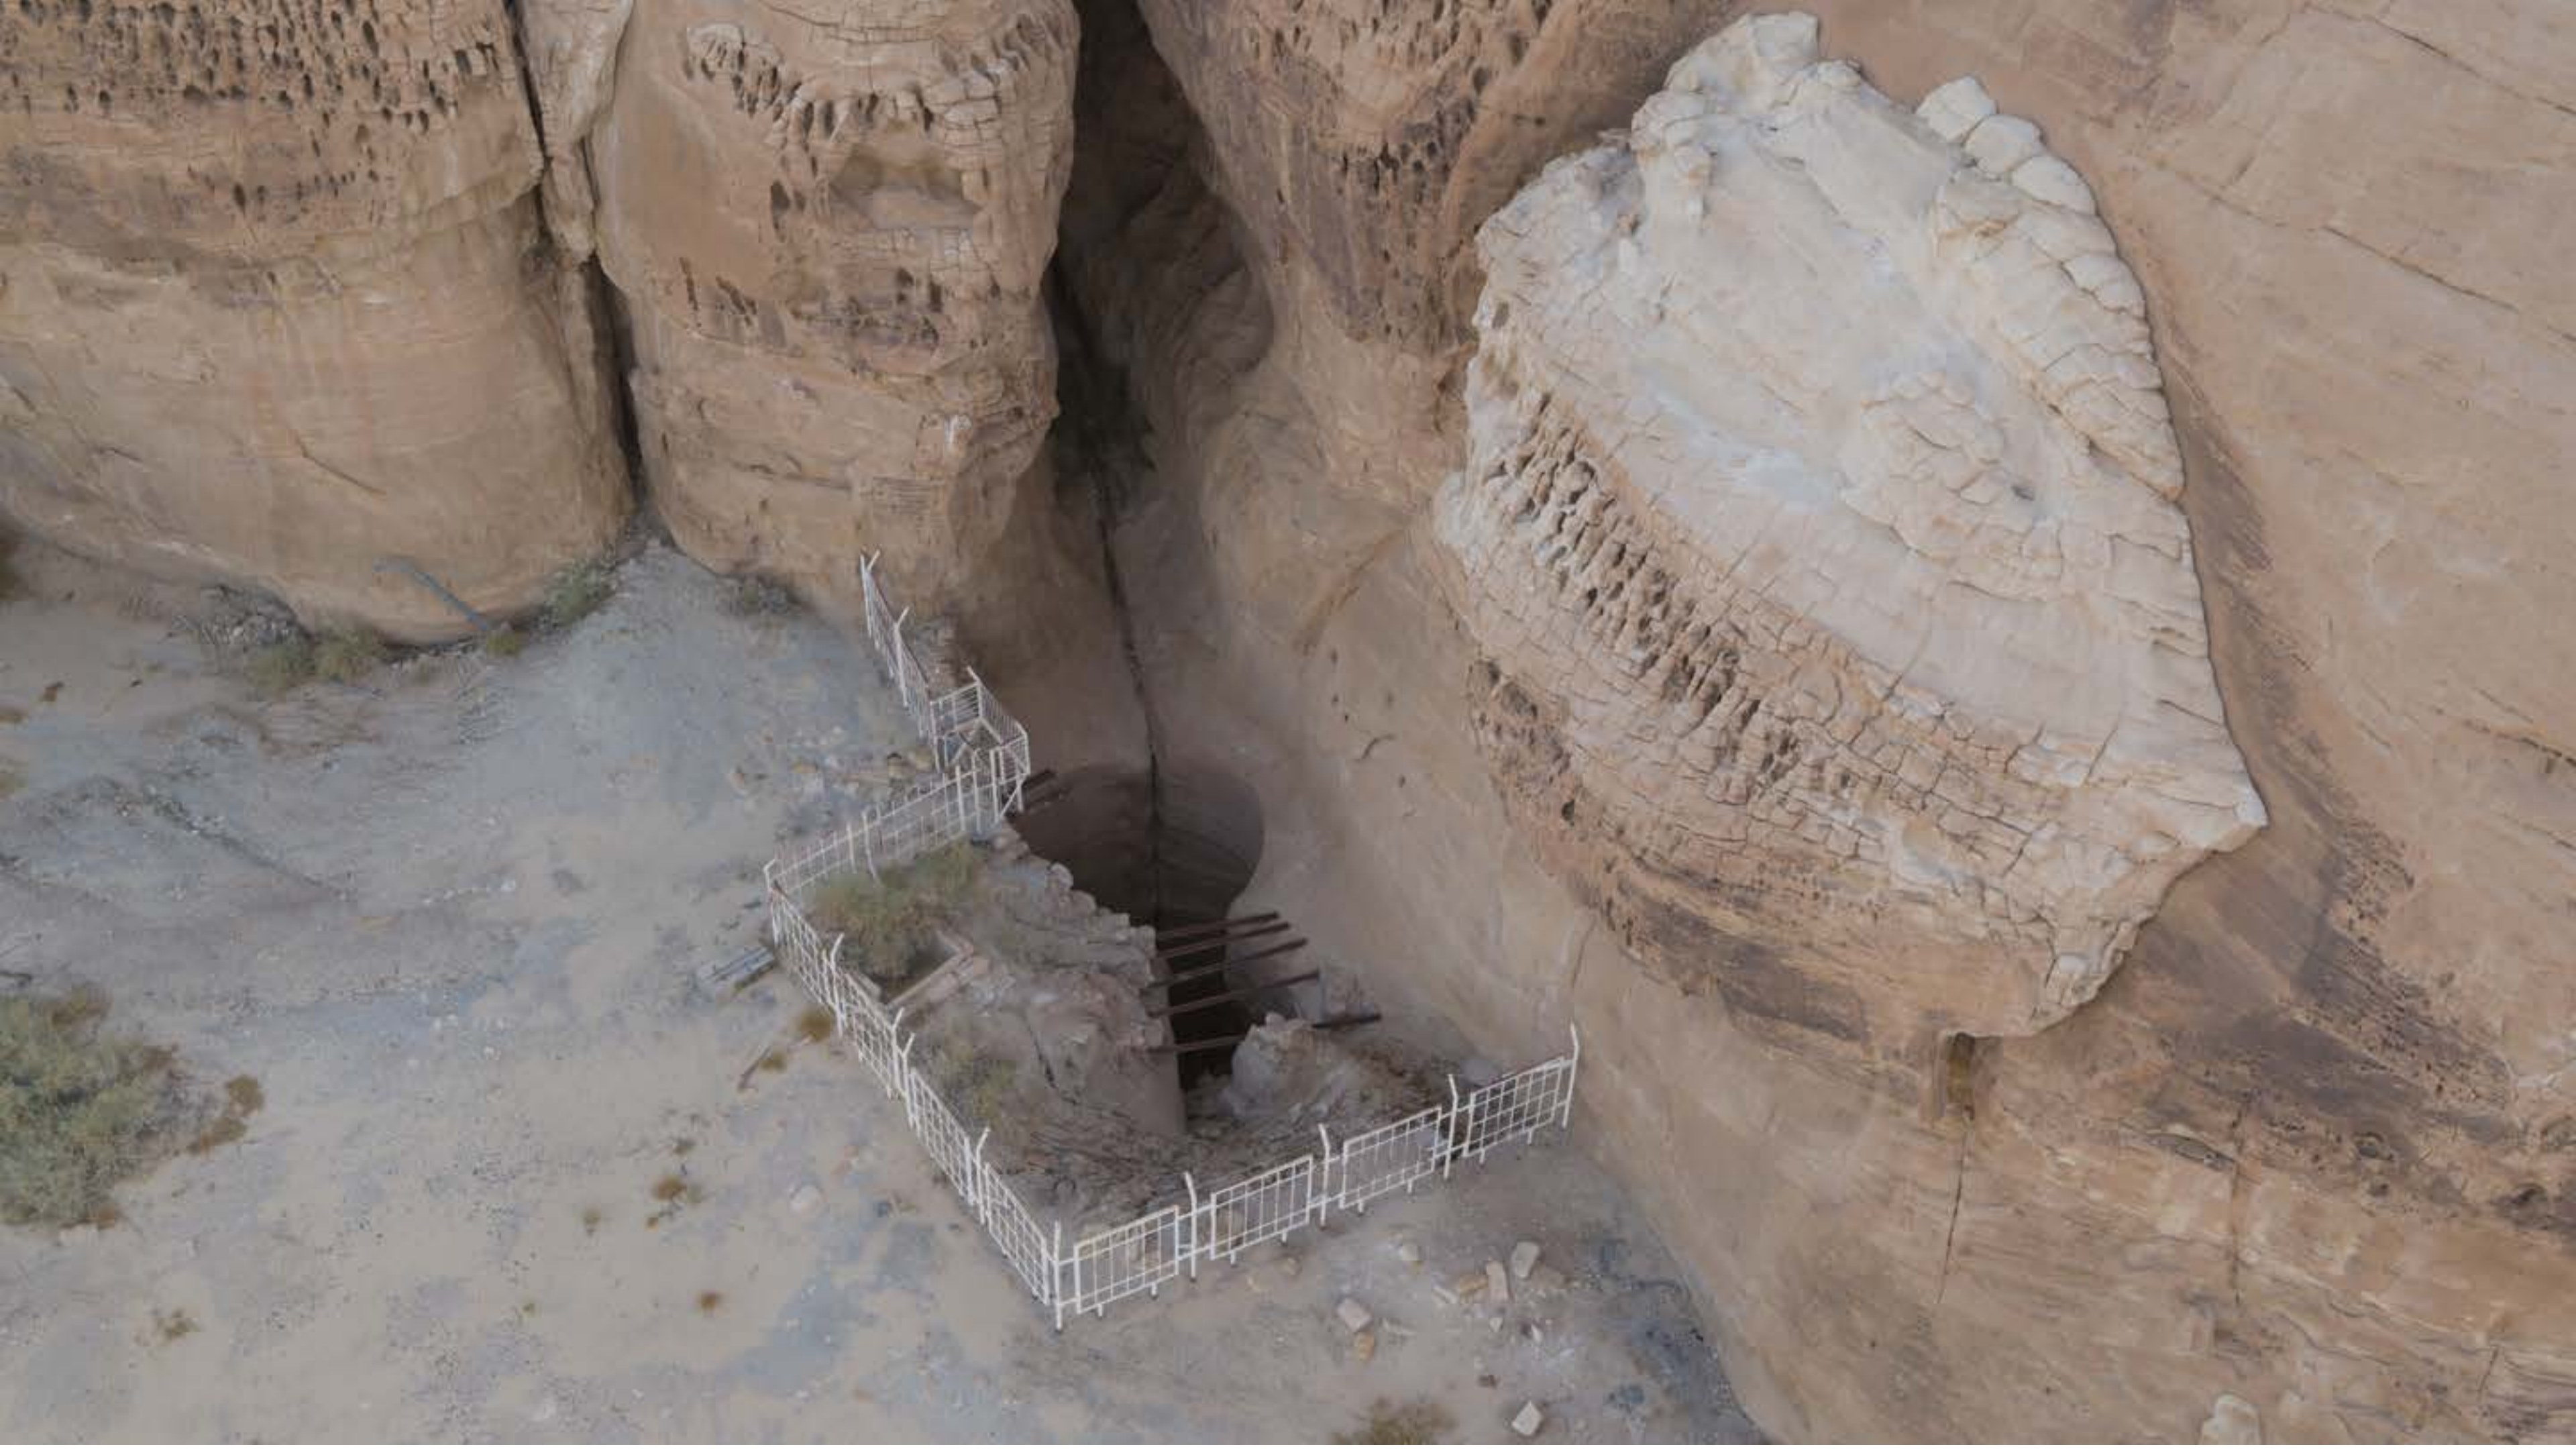
Point cloud (CloudCompare™)

Surfaces (Geomagic™)

3D Solids (MeshMidas FEA NX)

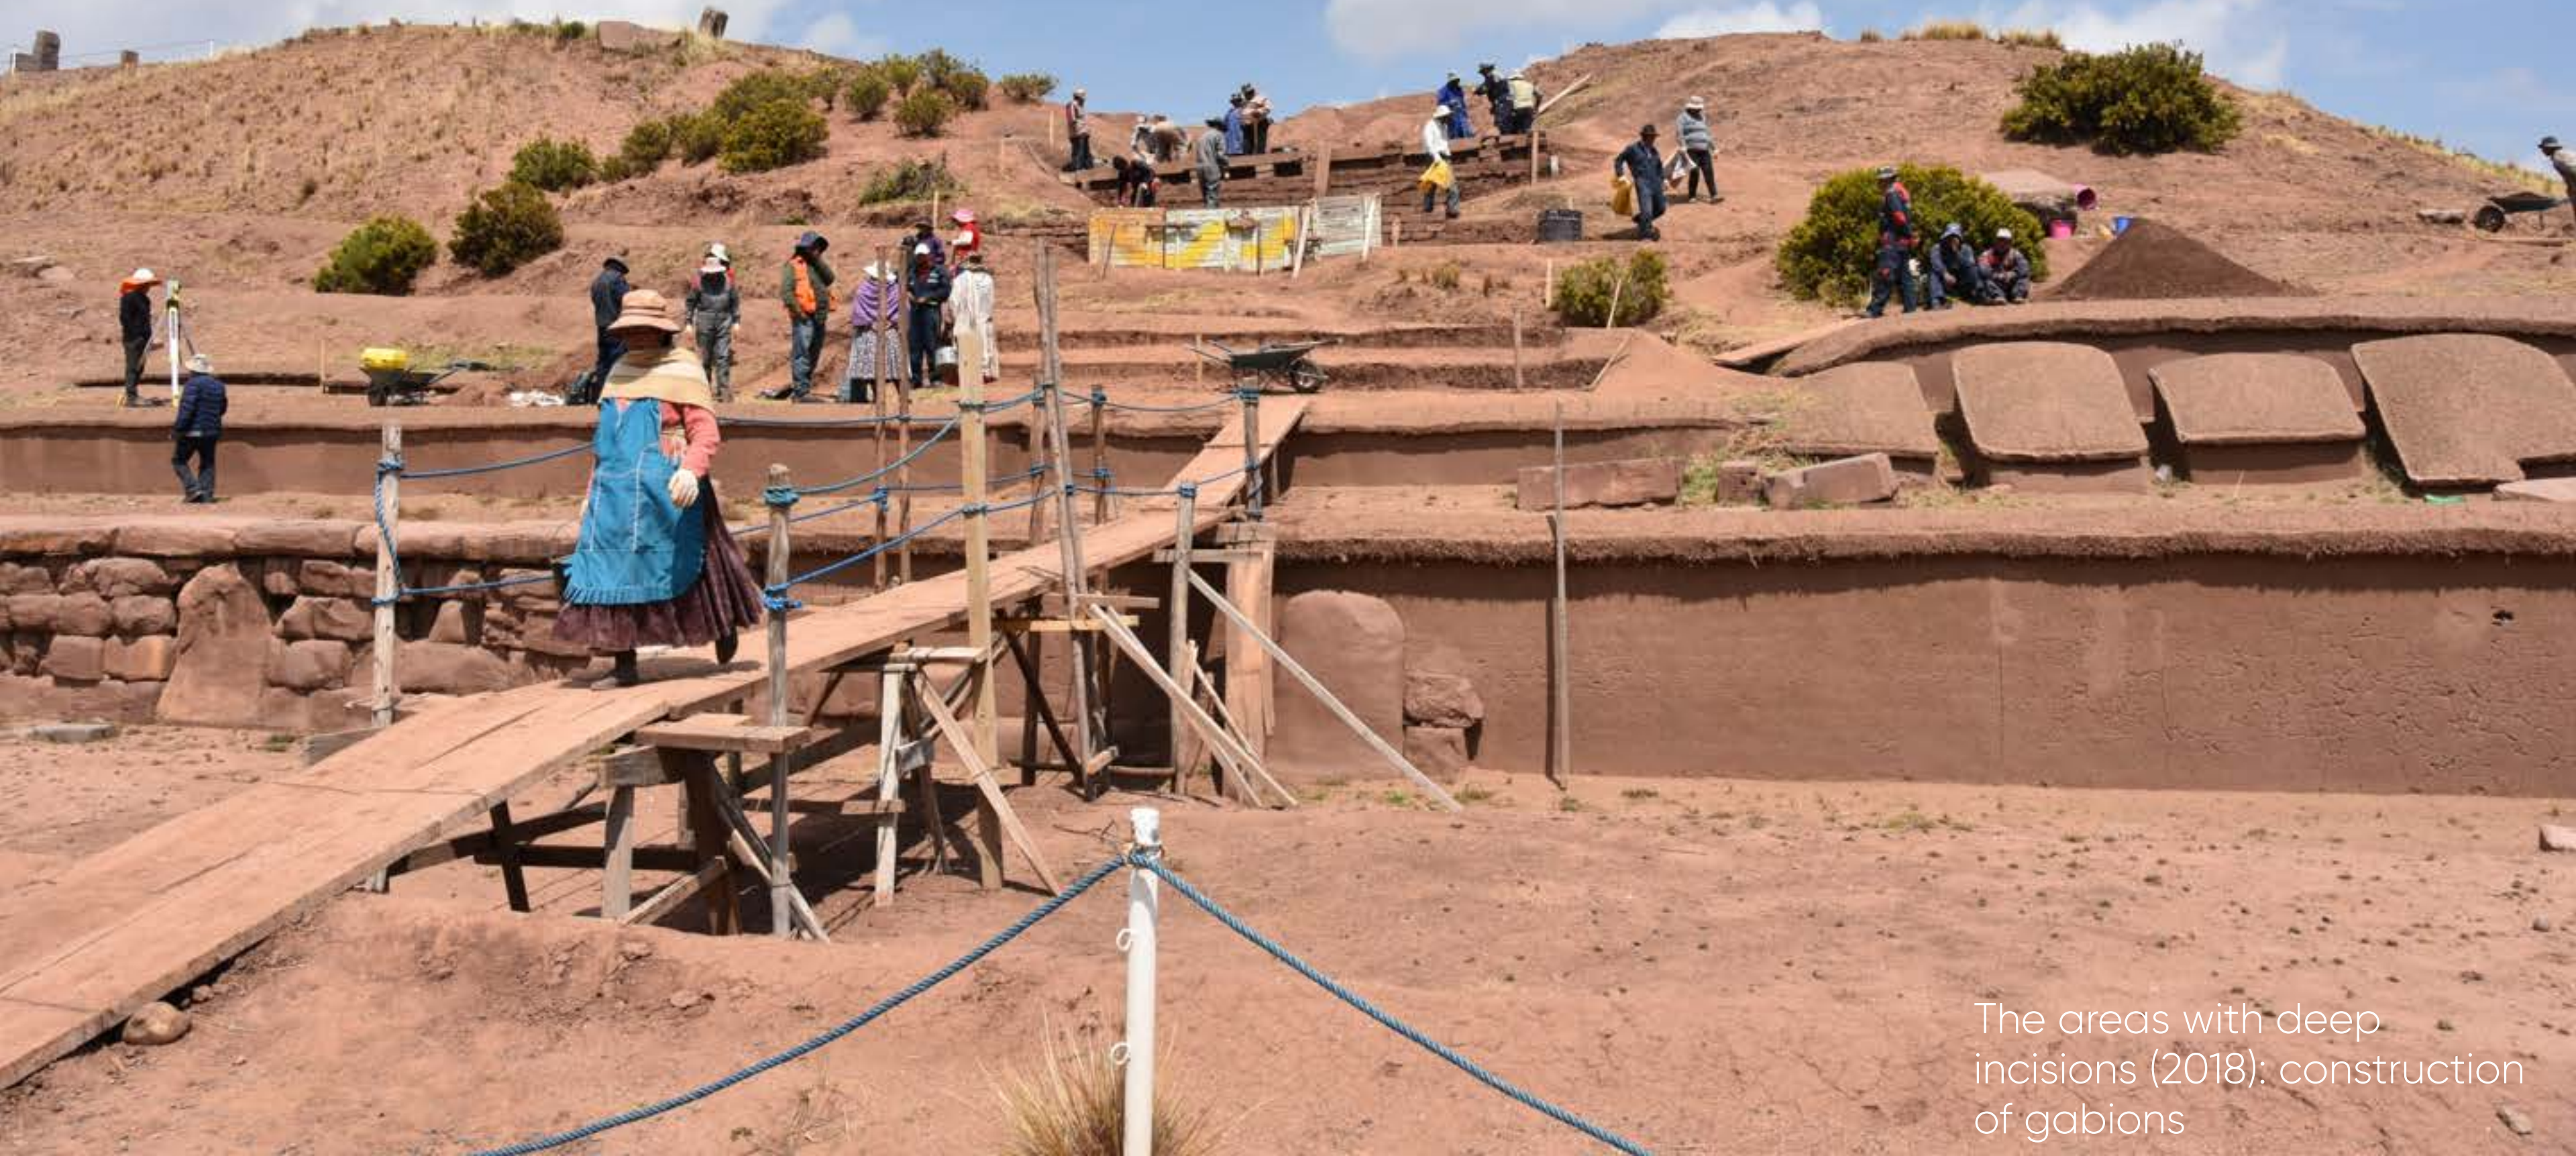
The areas with deep incisions (2018): construction of gabions

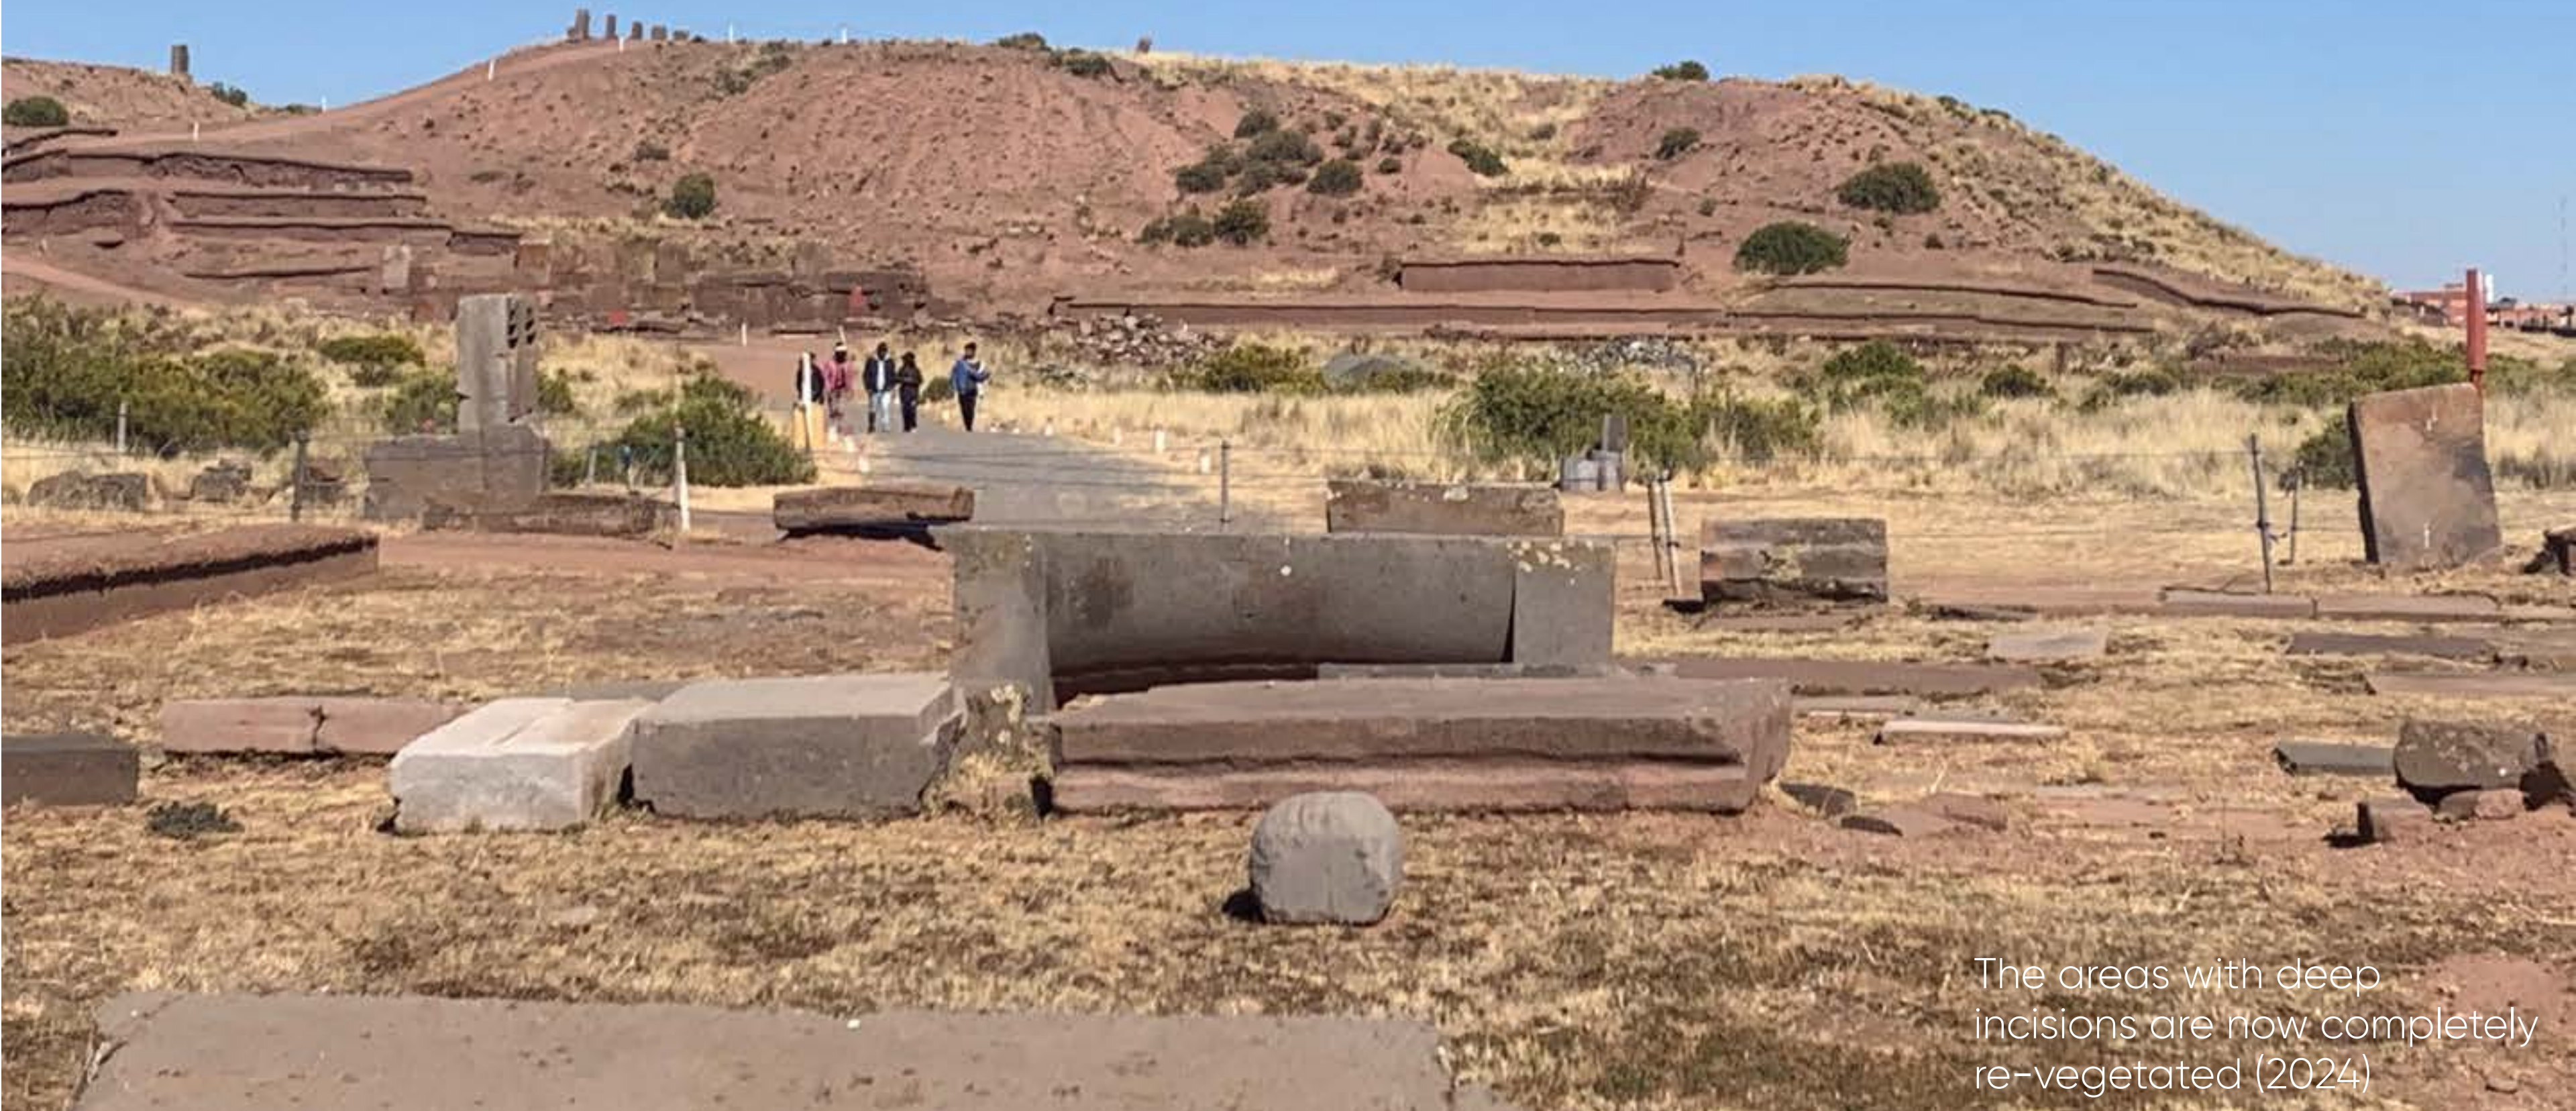
The areas with deep incisions are now completely re-vegetated (2024)

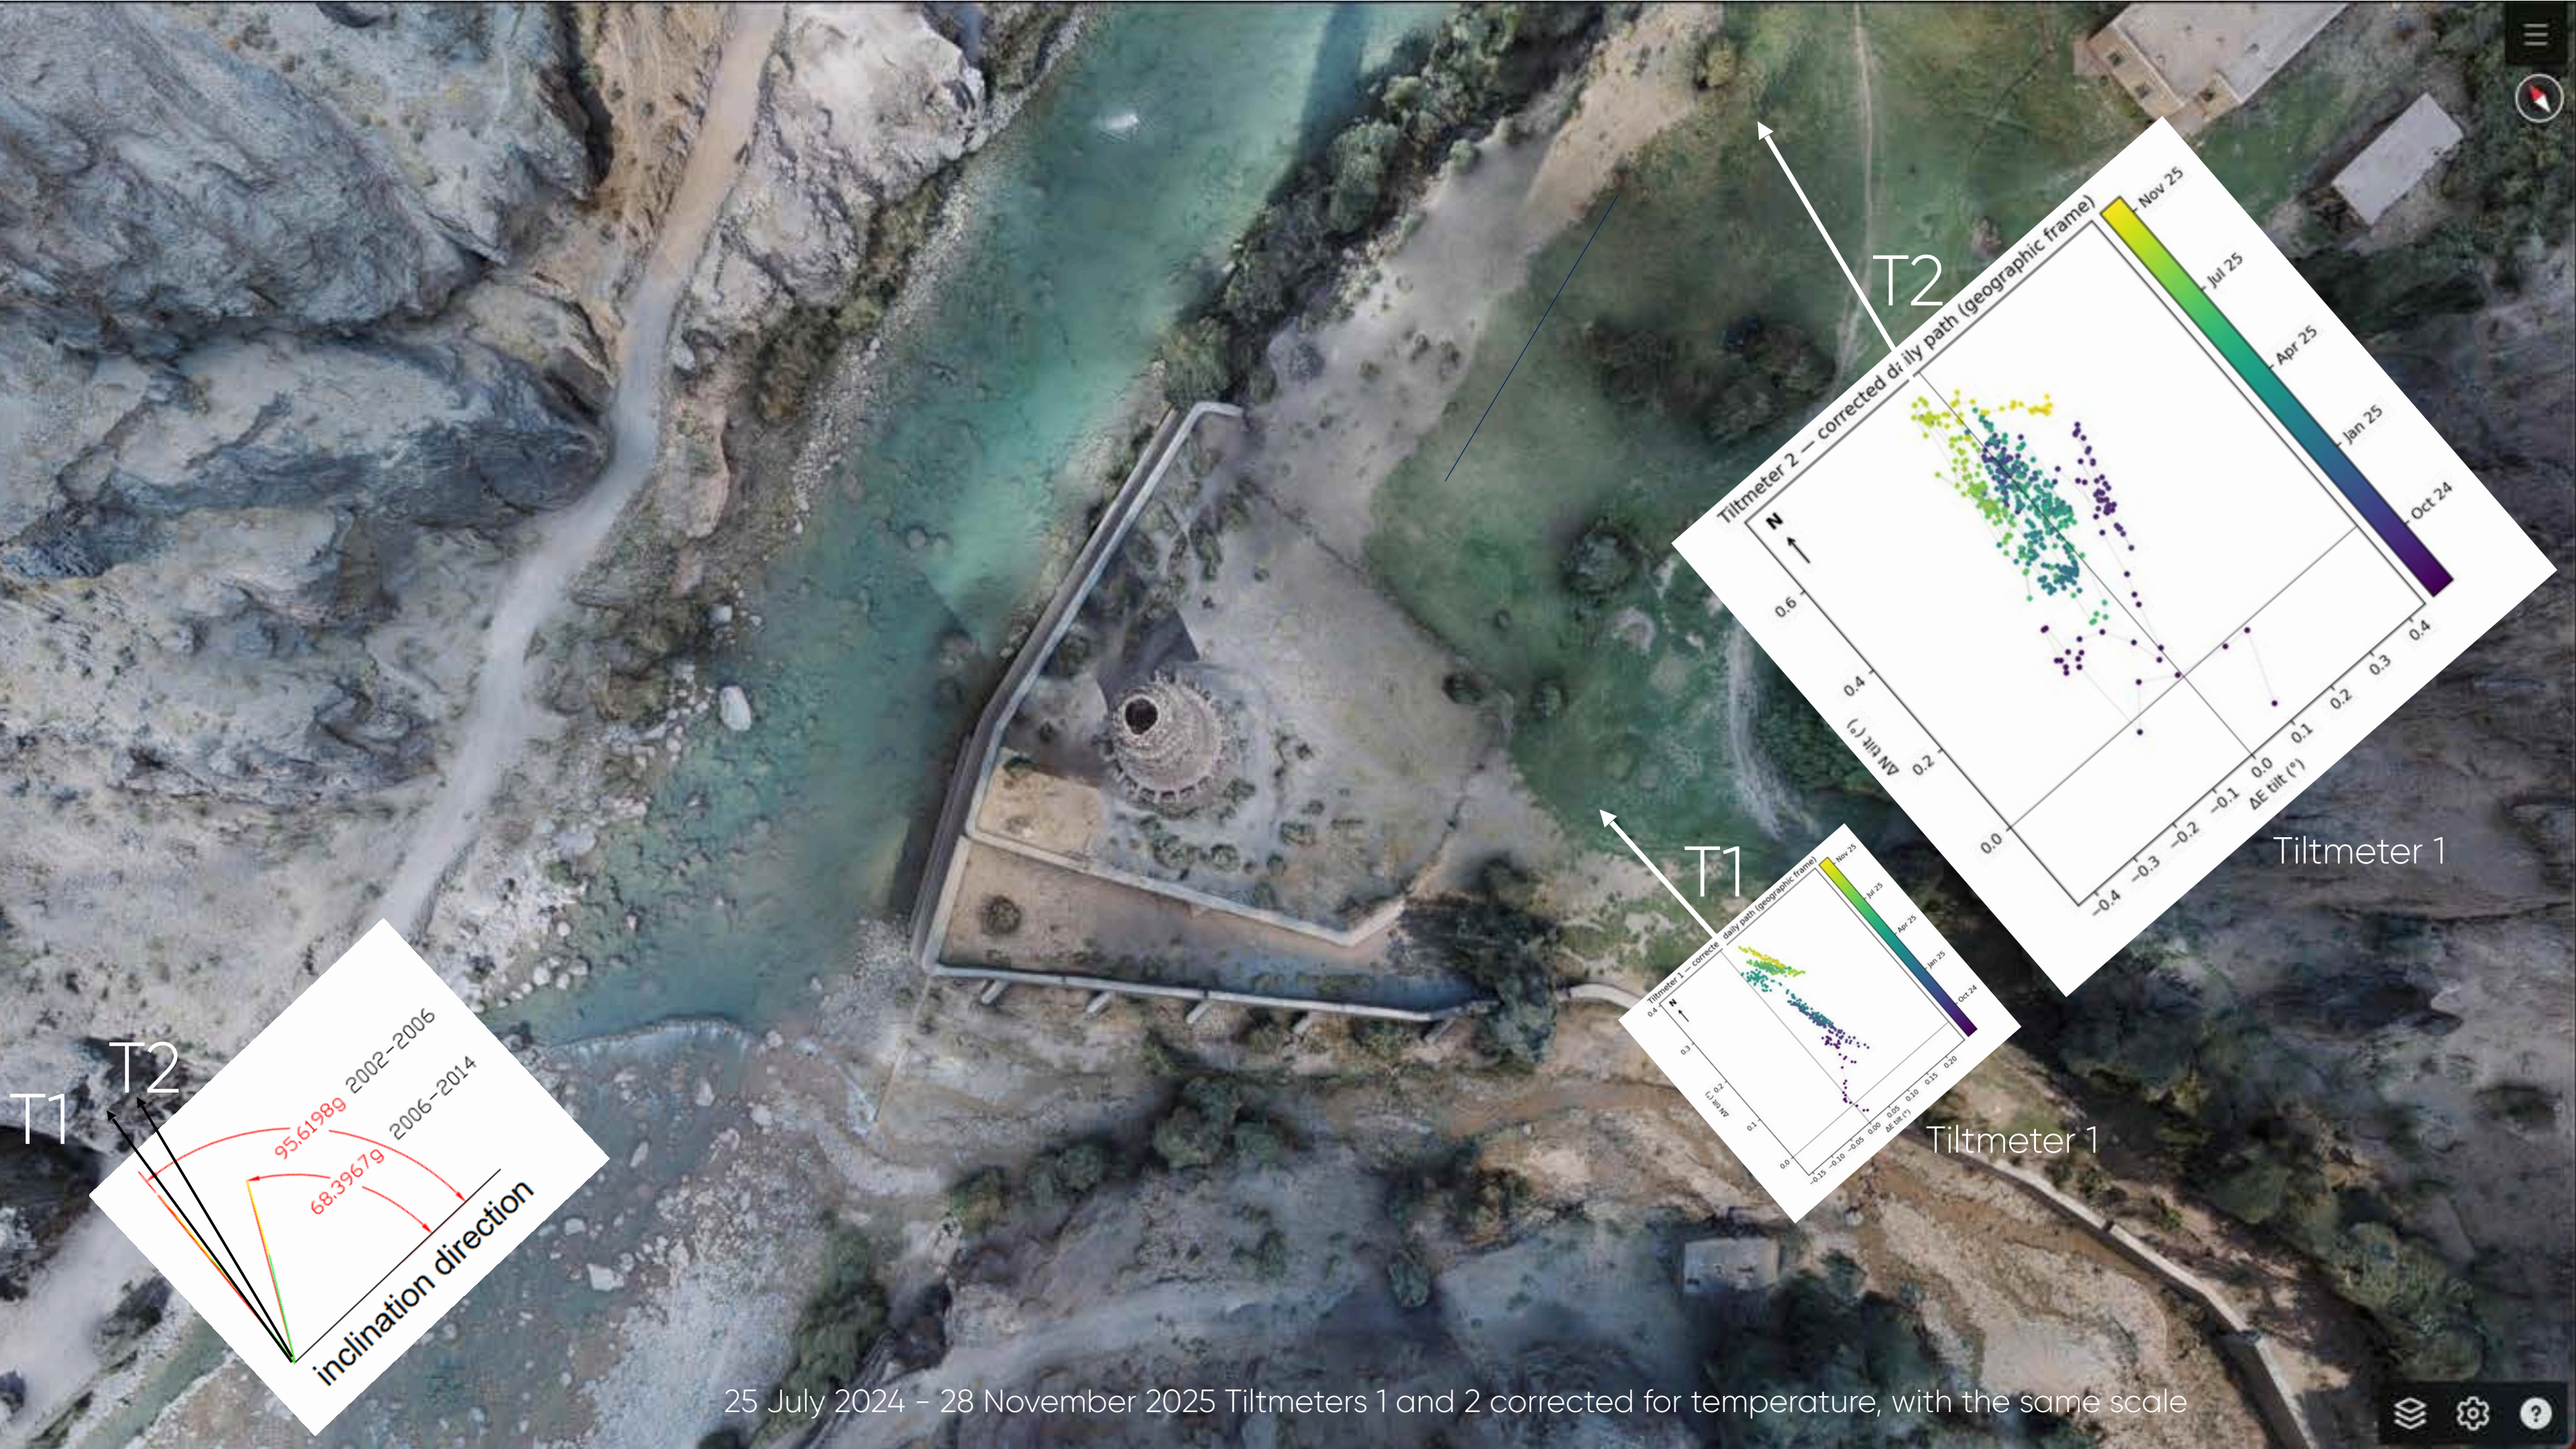
25 July 2024 – 28 November 2025 Tiltmeters 1 and 2 corrected for temperature, with the same scale

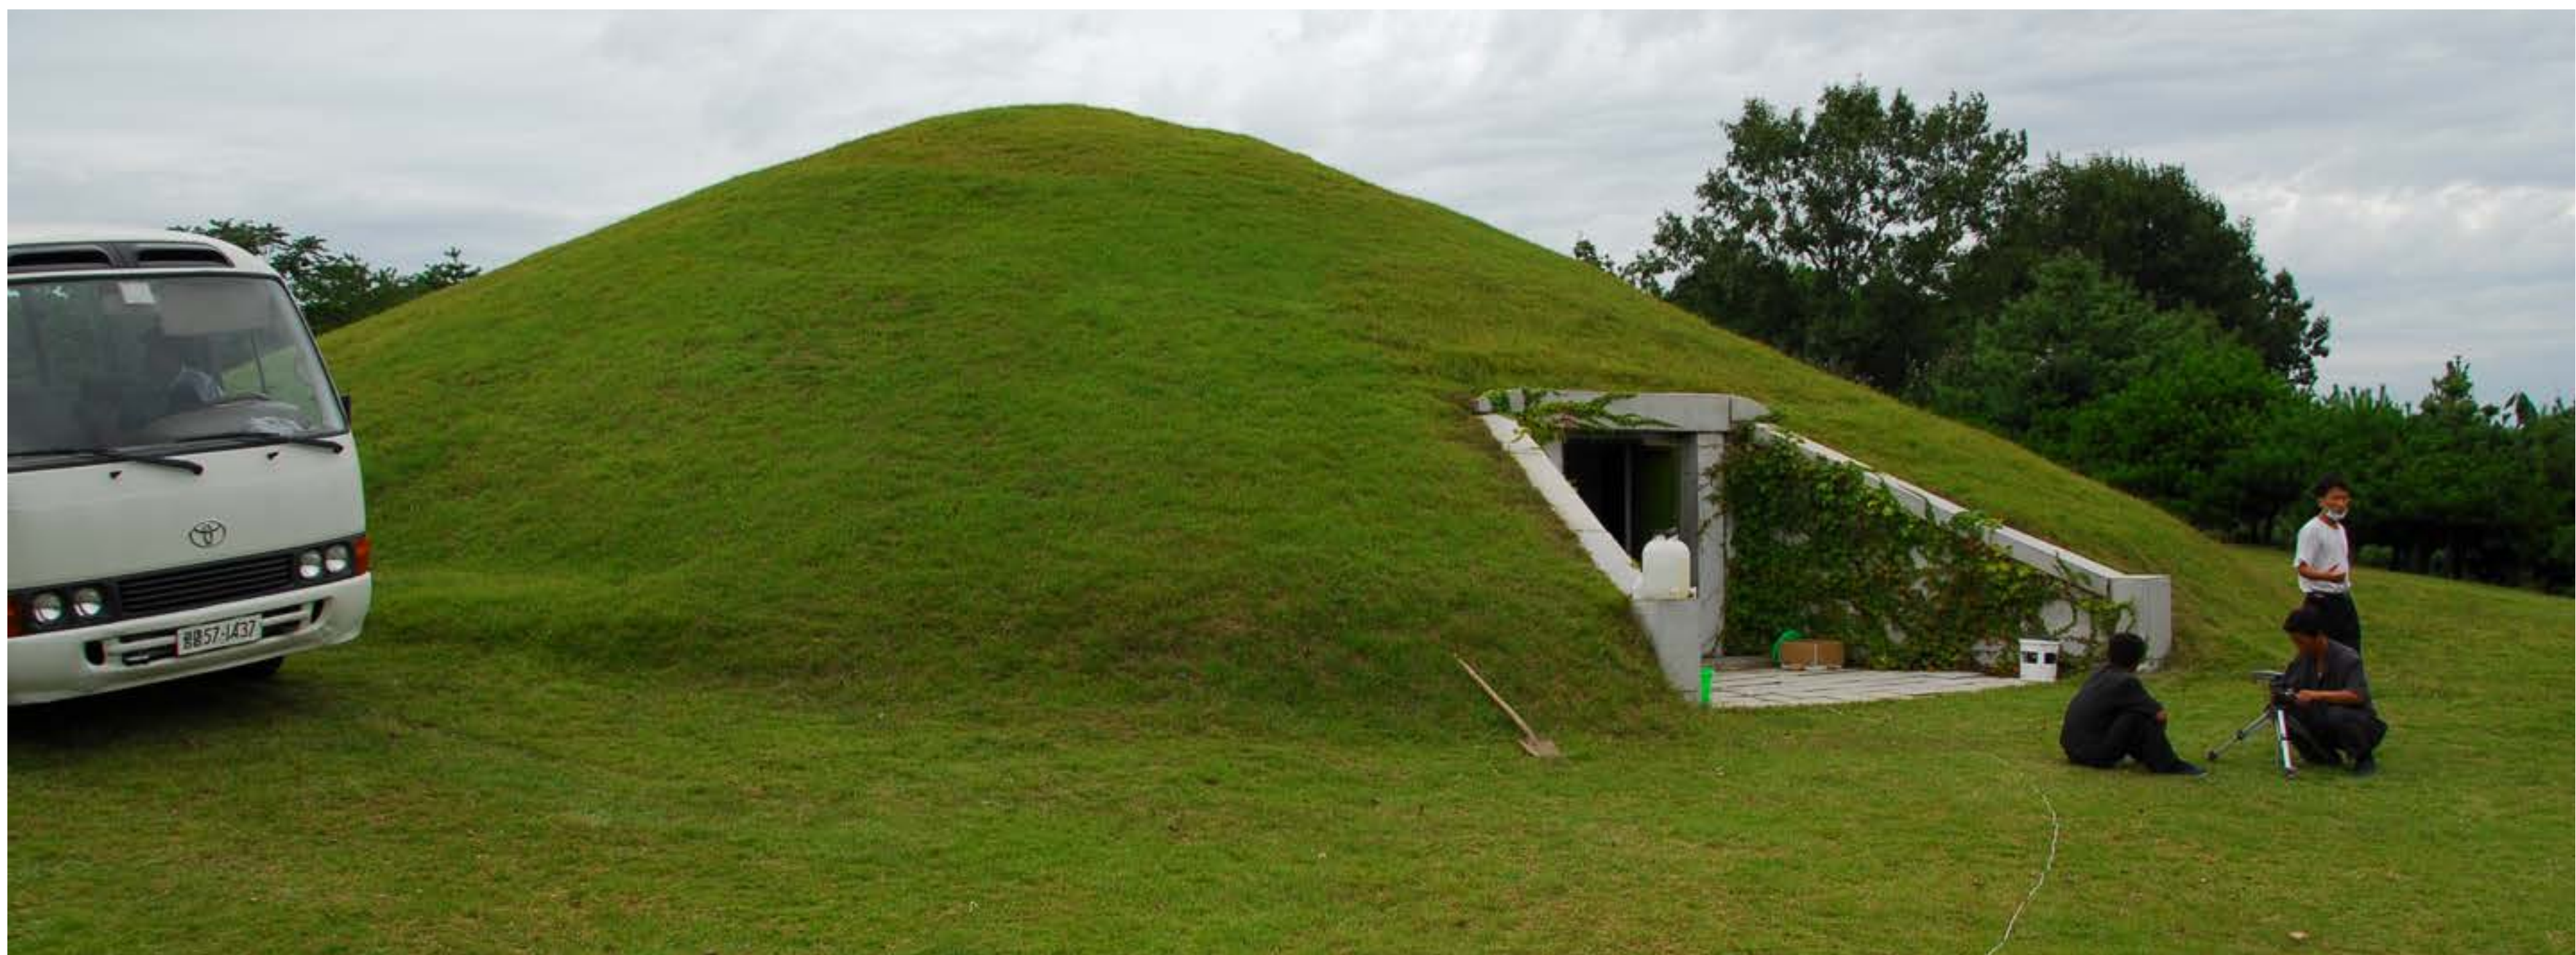
Water infiltration and flooding during heavy rainfall
