# Engineering Geology for protecting Cultural Heritages around the world: some case studies

**Claudio Margottini**

UNESCO Chair on the Prevention and  
Sustainable Management of Geo-  
Hydrological Hazards, University of  
Florence

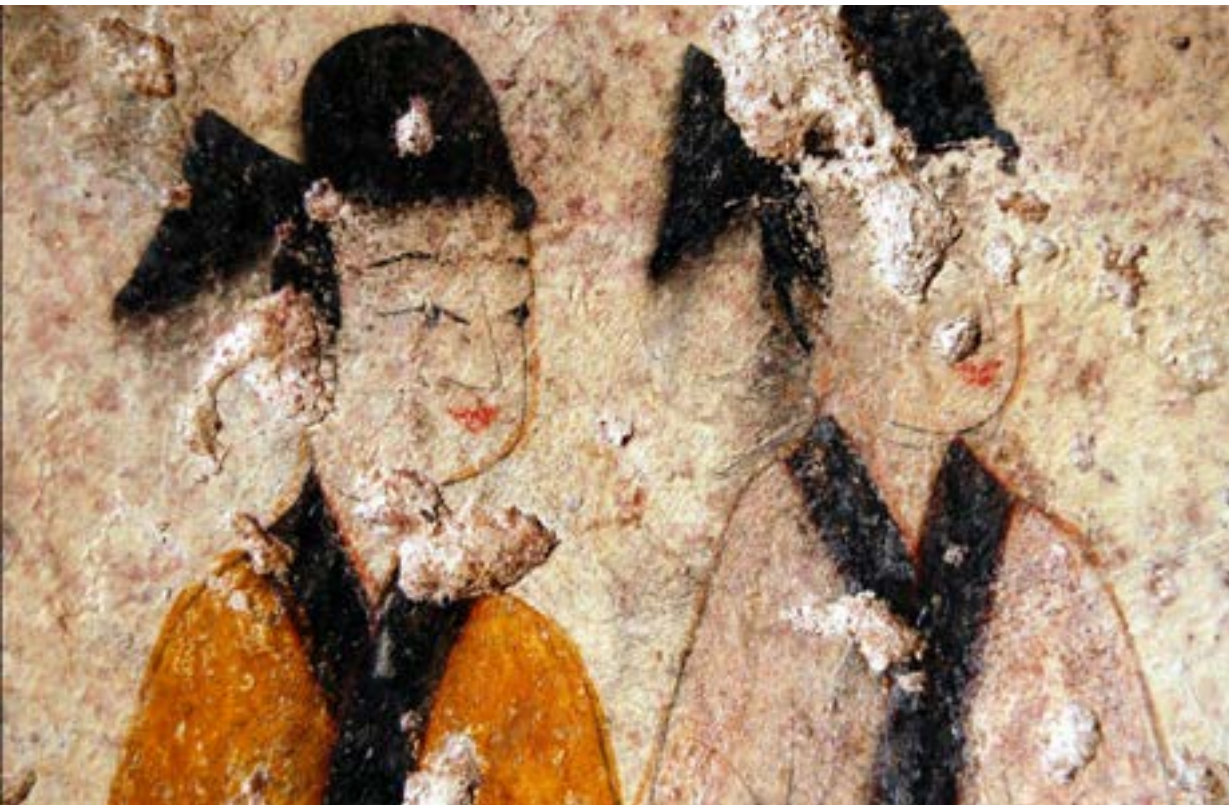
Damage on mural paintings

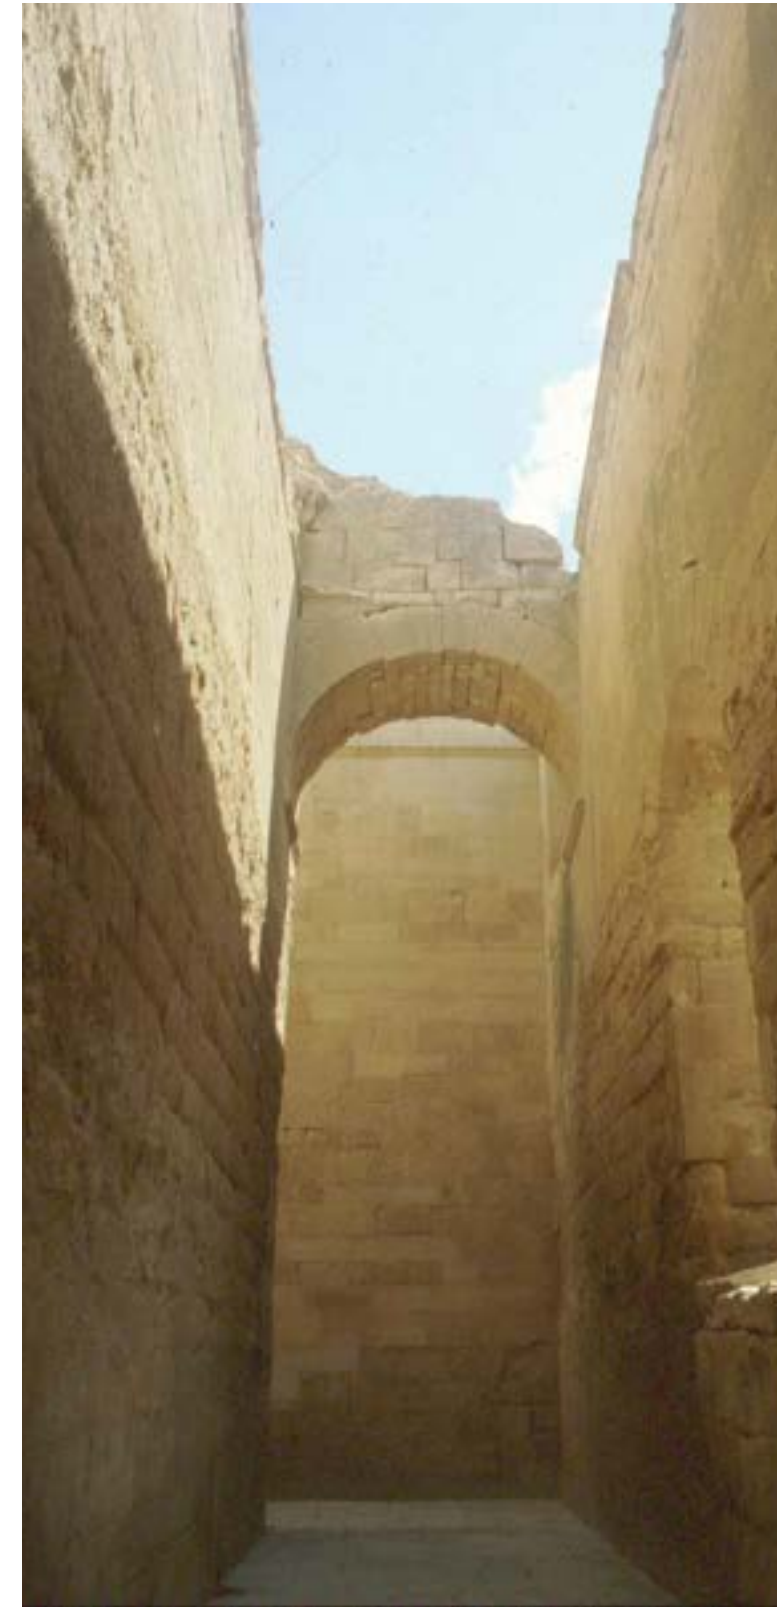
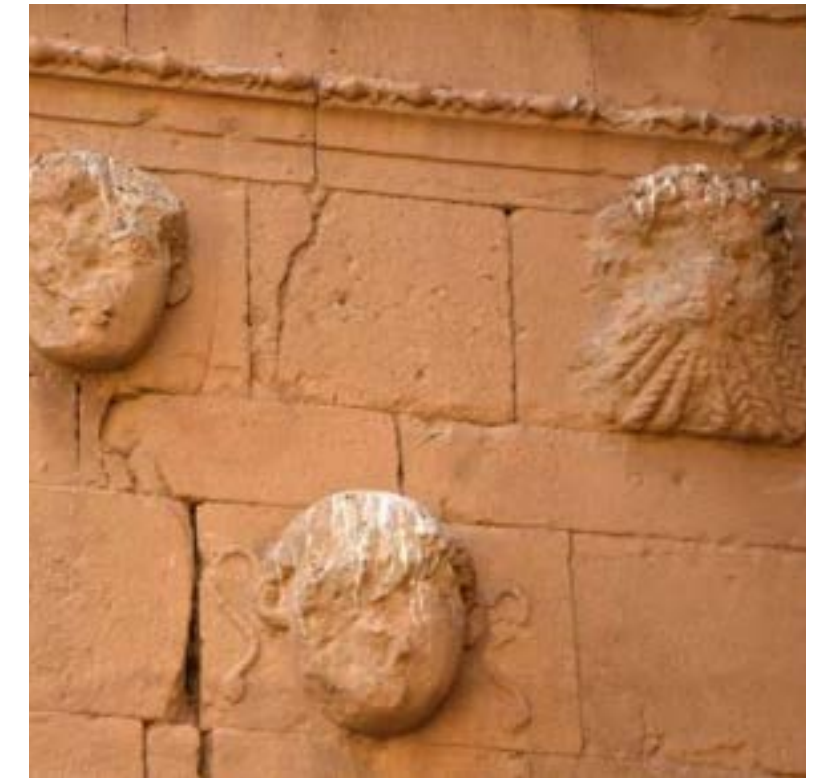
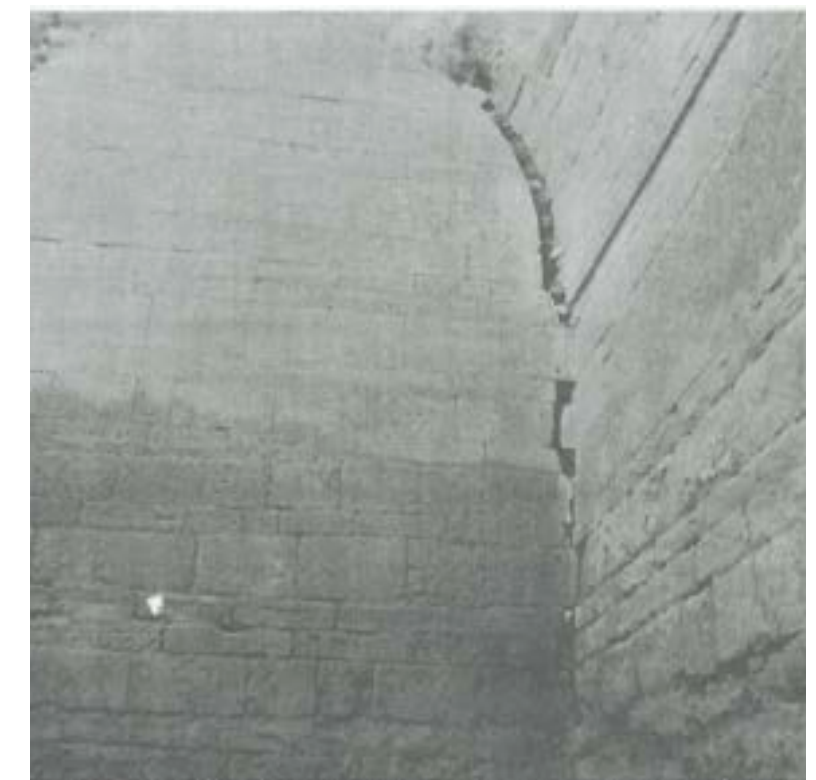
## Damage assessment

The result of this research performed in the historical site of Hatra demonstrated that probably, one or more earthquakes occurred near the city since its destruction in 250 A.D. The present damage likely referred to seismic motion(s) exhibit partial collapses and heavy deformations and fracturings, likely for the effects of different shocks. Nevertheless, the assessment of occurrence of vibratory ground motion is still controversial, even if some effects, like the ones of the enlargement of walls in North direction and the collapse of part of the walls in the same direction, are very difficult to explain with other reasons.

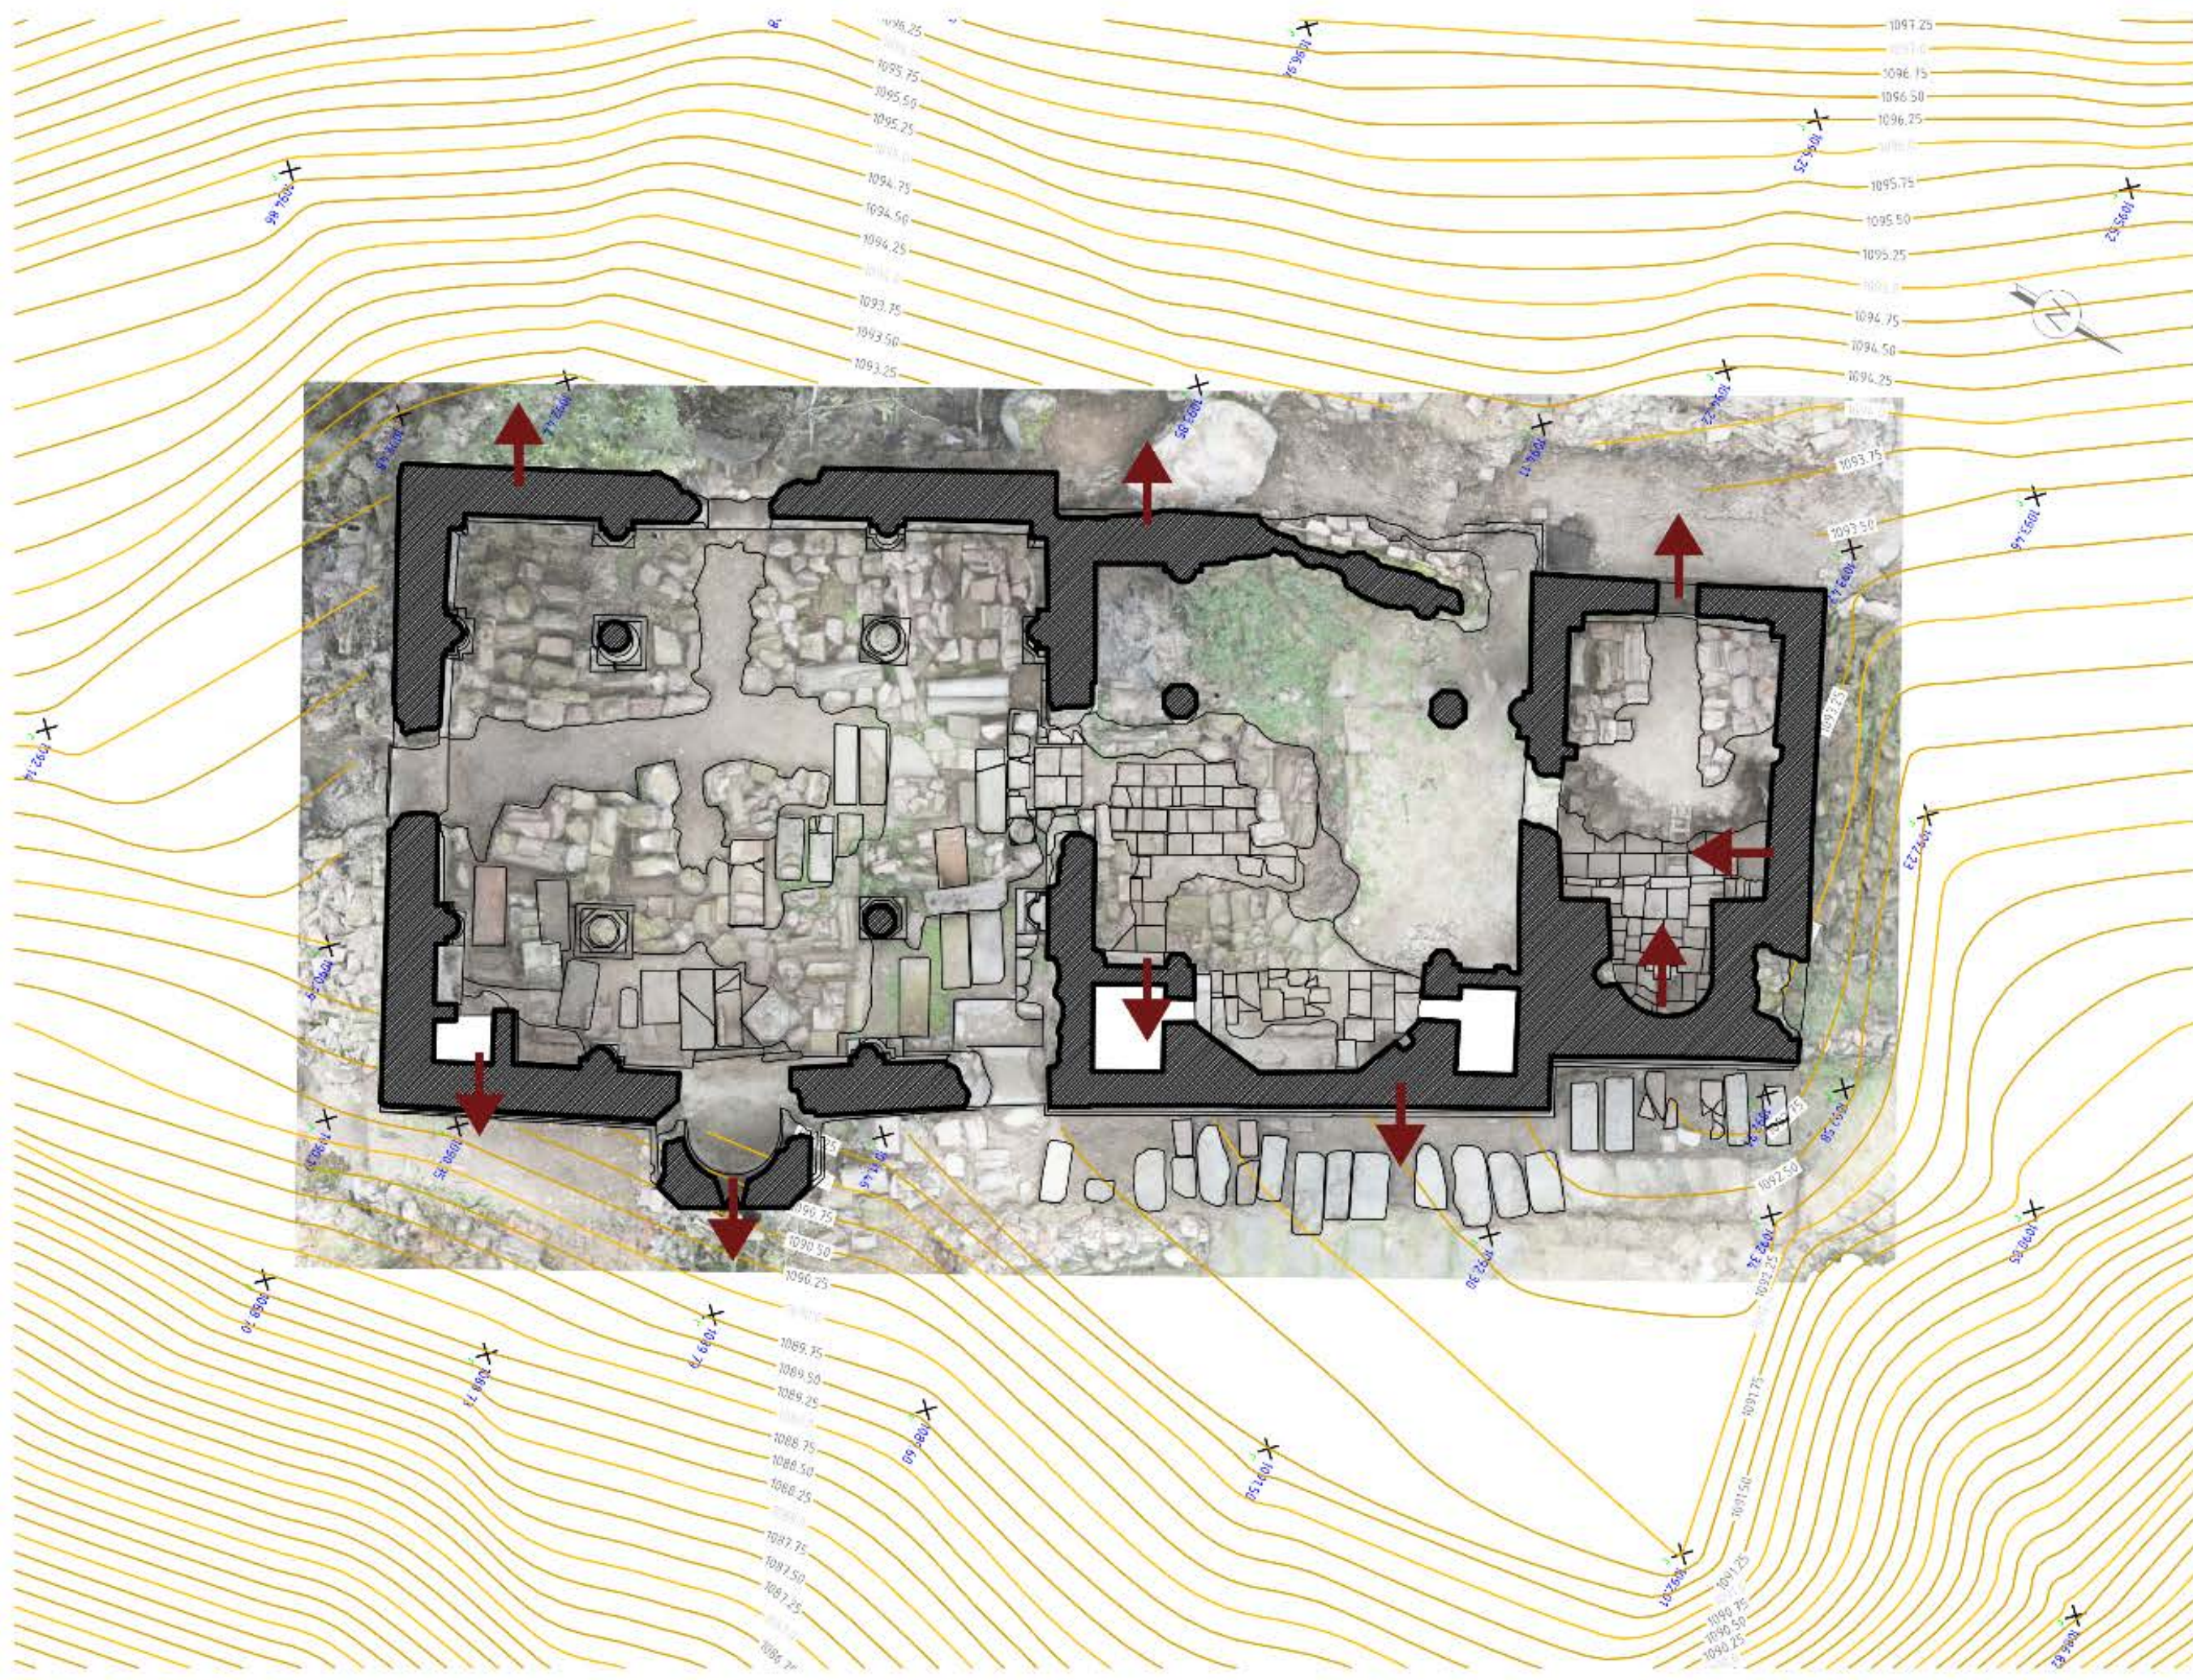
# Sketch of interpretative geophysical sections

3D

Rocky bedrock
